New solutions for Instrument's Sterilization

VES Annual meeting May 2018 Lisbon

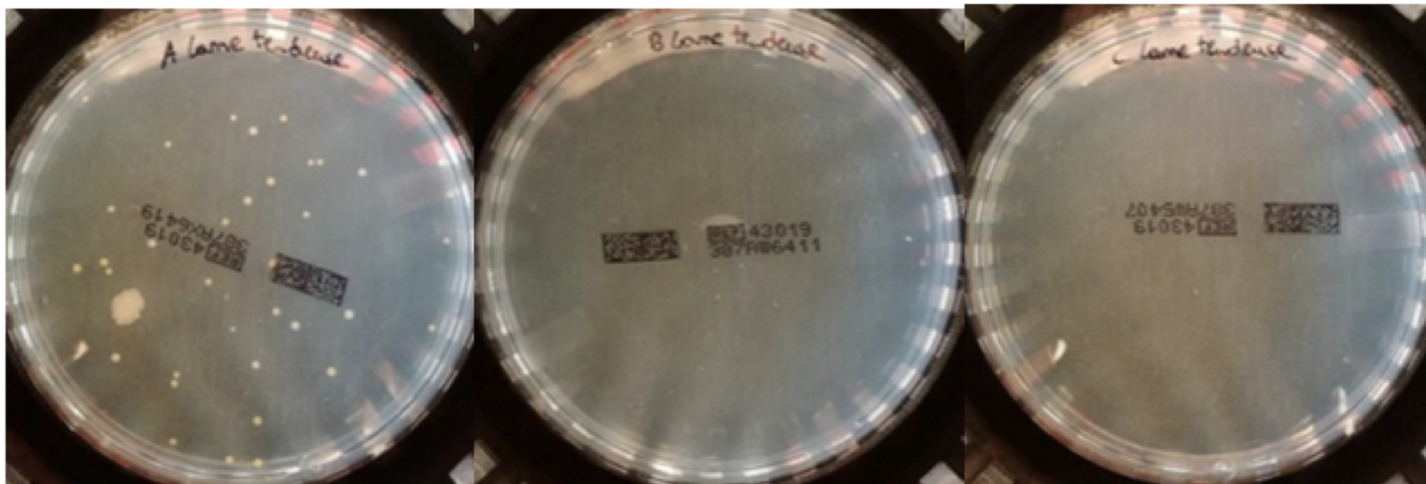
Shaver and Blade

We were given only the A sample of the Shaver. Around 400 CFU were found on this plate. Meaning that there were around 1200 CFU on the cotton swab that we were given.

Figure 27 Plated 0.5ml of 2ml solutions in which the cotton swabs of the shaver blade samples were put. On the left is the sample before sterilization, in the middle is the sample after cycle 23 and on the right the one after cycle 24.

On the A plate of the shaver blade were around 40 CFU (10 times less than for the Shaver itself). No colonies were found on the B and C plates, meaning the low dose of the cycle 23 was sufficient to kill all the CFU.

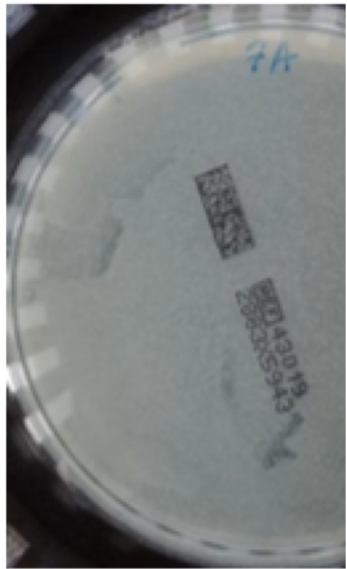
Figure 11 Plated 0.6ml solution in which the cc 7A was placed.
